Proceedings of the Risø International Symposium on Materials Science

WIND TURBINE BLADE TESTING UNDER COMBINED LOADING

A. Roczek-Sieradzan, M. Nielsen, K. Branner,
F.M. Jensen and R. Bitsche.

Wind Energy Division, Risø National Laboratory for Sustainable
Energy, Technical University of Denmark, Roskilde, Denmark

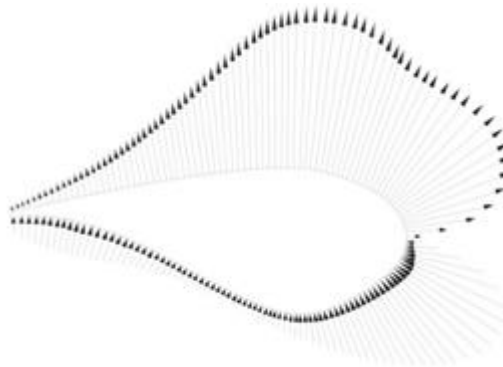
Fig. 1. Pressure distribution on an aerodynamic profile generating the aerodynamic loads.

2.1 Combined Load Case Background. Under normal operation the blade profile is moving towards the wind at a small angle. The resulting aerodynamic force is therefore mainly pointing flapwise towards the suction side, and slightly angled towards the leading edge. A typical load in the flapwise direction is shown in Fig. 1.

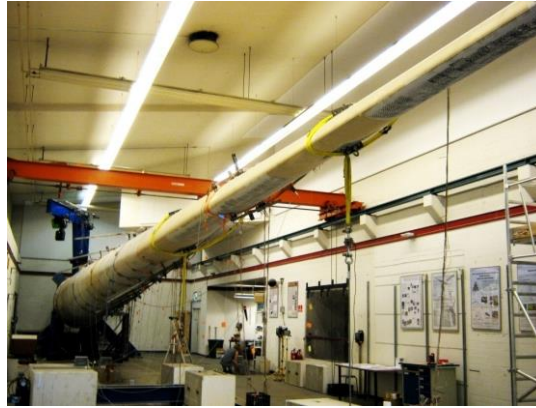
Fig. 2. The blade bolted to the test rig. The tip was truncated at 25m. The blade is loaded at a 30° angle to the flapwise direction, simulating combined flap- and edgewise loads.

2.2 Loading. For the combined load test the blade is mounted on the test rig as shown in Fig. 2. This loading method is based on a new concept and the process of test preparation and load application is described in more details in (Nielsen, Nielsen et al. 2010). The way the blade is positioned allows the force to be applied on the suction side of the blade pulling towards the floor, which creates an angle of 30° with the flapwise plane.
